ALUMINUM LIGHTWEIGHT ORTHOTROPIC DECK EVALUATION PROJECT

FLORIDA DEPARTMENT OF TRANSPORTATION
M. H. ANSLEY STRUCTURES RESEARCH CENTER
WRITTEN BY: CHRISTINA FREEMAN, P.E.
REVIEWED BY: WILLIAM POTTER, P.E.
2017

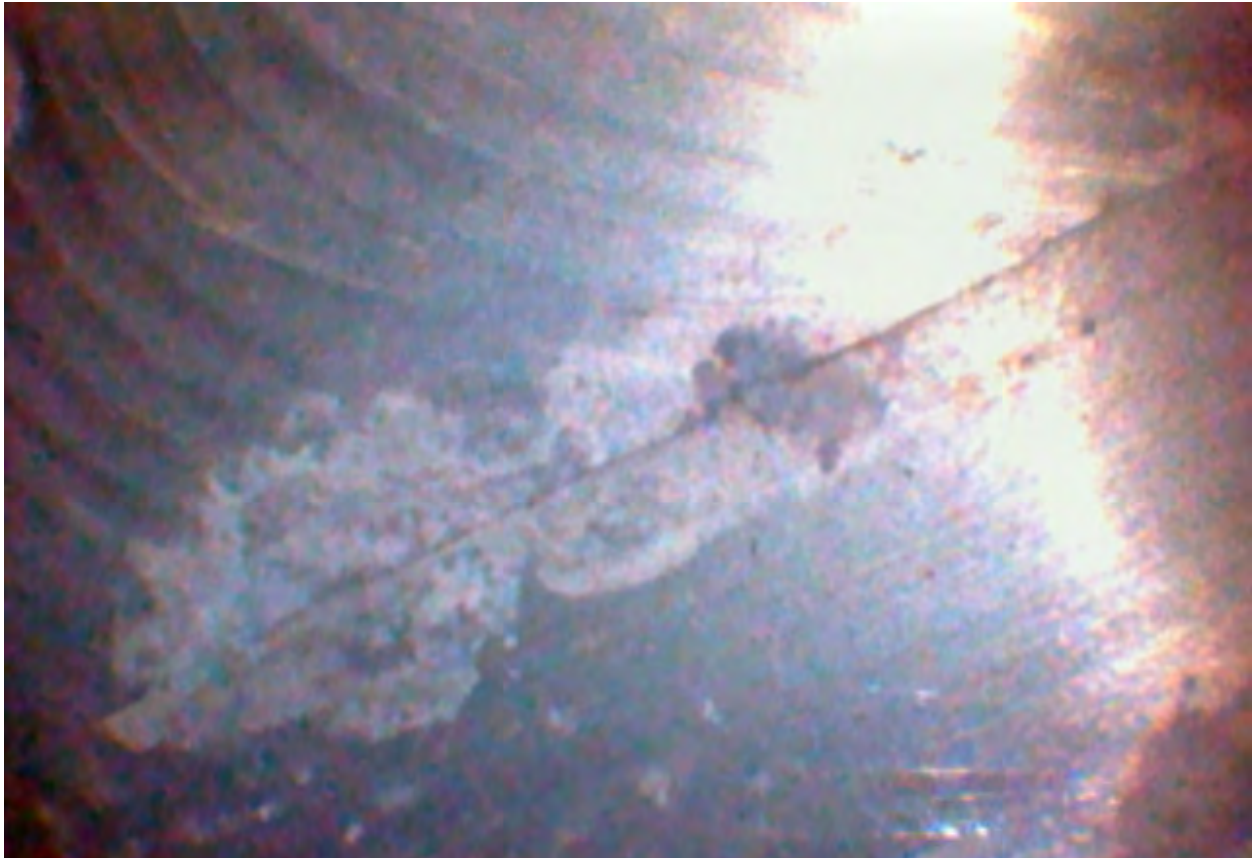
Figure 3: Bore Scope Screenshot at Internal Weld

preliminary inspection only. The photographic inventory and bore scope video showed some very minor general corrosion, visible as white spots in the photographic inventory in Appendix E: Visual Inspection Photo Inventory and in Figure 3.

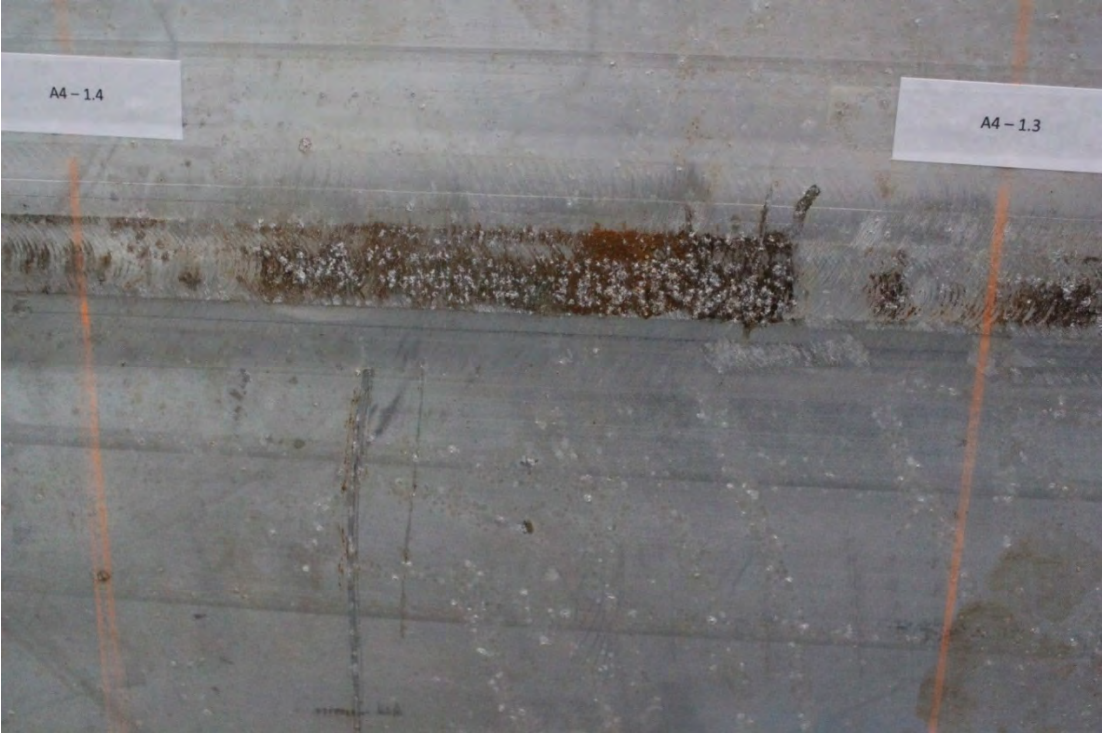
Figure 4: Corrosive Staining at Weld A4

The photographic inventory documented brown colored corrosive stains along the bottom of welds 2 through 6 in the generation I panel and the bottom of welds 1-3 in the generation II panel. Staining varied from severe, covering the entire weld surface for several inches, to minor, covering part of the weld surface. Examples of each are shown in Figure 4 and Figure 5. In general, the staining was more severe for the generation I panel than the generation II panel. The stains do not appear to be active corrosion and no section loss was measured. The extent and severity of the brown colored corrosive stains did not increase between the preliminary and final inspections. The stains are most likely due to contact with bare steel, which could result in galvanic corrosion due to the dissimilar metal. The weld material appears to be more susceptible to corrosion than the adjacent unaffected material. The aluminum plate adjacent to the weld rarely had corrosion stains as severe as at the weld. An exception is shown in Figure 6. In general, any weld is more electrochemically active than surrounding metal, potentially because of a different microstructure, residual stress or loss of temper. Texture of the weld seam could also allow water to pool or bead. Metallographic analysis would require destructive testing and if it were performed the deck could not be placed in service for a trial period in an existing bridge. Therefore, growth of current staining should be monitored during the trial installation of this deck. If required, metallographic analysis could be performed

after the test specimen is removed from service. For future manufacturing, minimizing contact with steel, a dissimilar metal, could reduce or eliminate this type of staining.

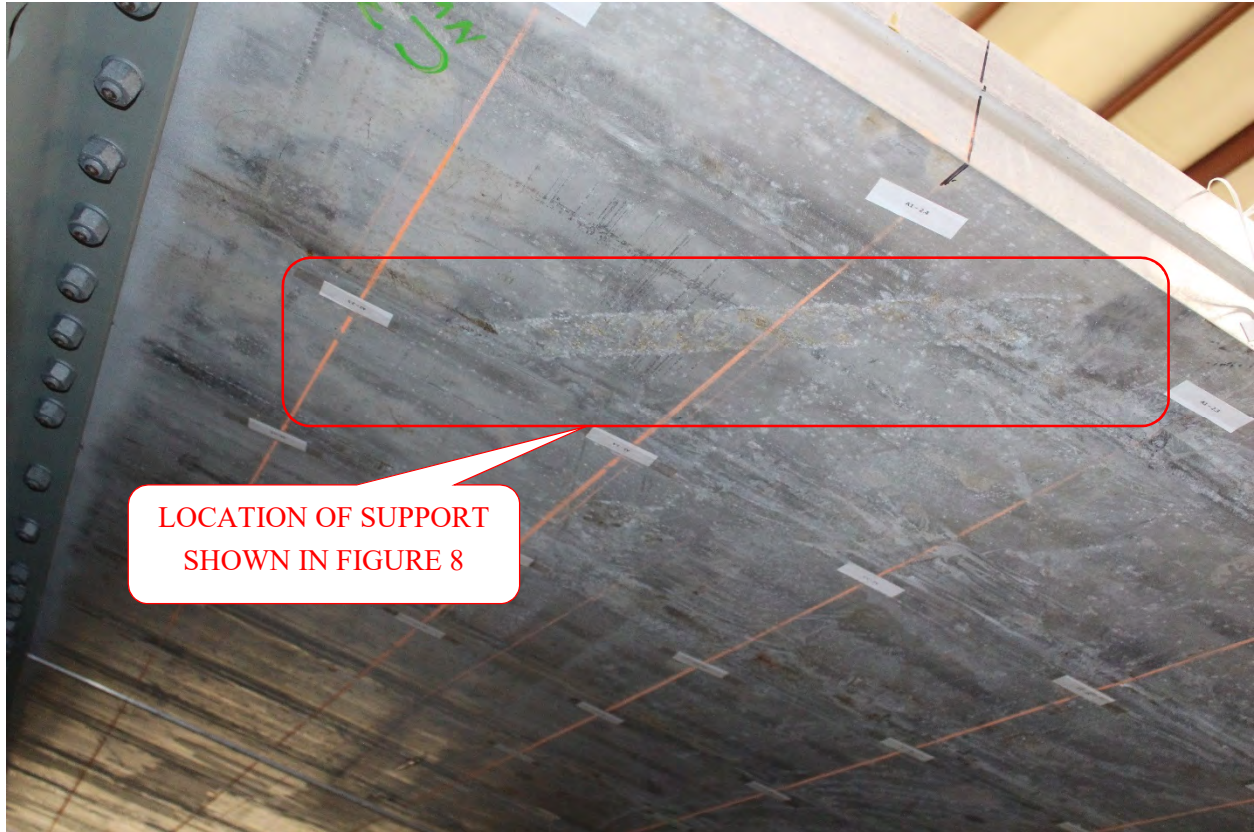
Figure 7: Corrosive Staining at Generation I Panel

Additional evidence of galvanic corrosion documented during the preliminary photographic inventory consisted of a diagonal affected area approximately 2 inches wide and eighteen inches long, located between stringers 2 and 3 on the generation I panel. Galvanic corrosion is evident by rust colored staining and minor pitting, shown in Figure 7. Figure 8 shows the aluminum panel was supported by bare steel during storage. The location of the supports coincides with the documented galvanic corrosion, therefore the corrosion is likely due to contact with dissimilar metals during fabrication. For future use, Specifications should be incorporated to ensure proper handling during fabrication and installation. The manufacturer and contractor should have proper quality controls in place to verify the aluminum does not come in contact with dissimilar metals during the fabrication process. If proper controls are not in place, service life of the product could be reduced.

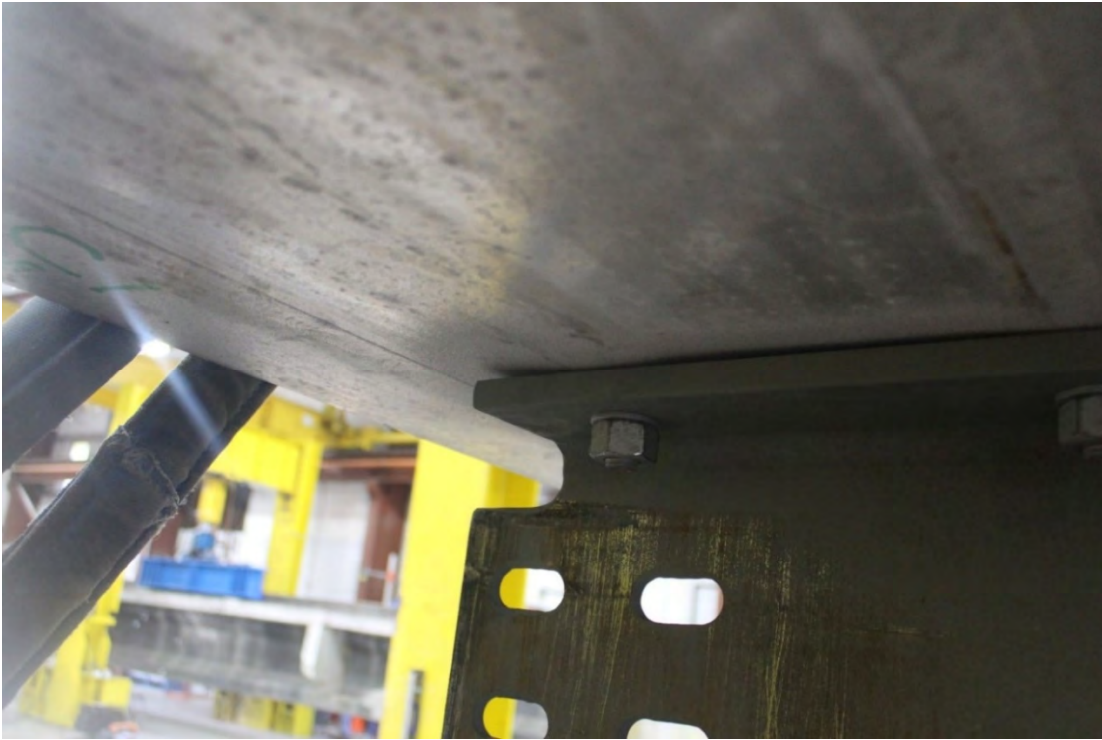
Figure 11: Gap between Steel Stringer and Generation I Aluminum Panel

The generation I panel has a top and bottom plate with unequal thickness. The differential stiffness between the top and bottom plates caused minor distortion upon welding the extrusions together. The stiffer top plate contracted, resulting in a negatively cambered shape. During attachment to the steel stringers, the aluminum panel was forced down for contact with the stringers. The force was enough to cause local distortion of the panel around the bolt hole. Contact was achieved between the panel and stringer at each bolt, but not between bolts. The result is uneven contact between the panel and beam, as shown in Figure 11. In general, the gap is more pronounced close to the free end of the aluminum panel. Although the generation II panel did remain flat during the welding process, a gap between the panel and stringer is still present, as shown in Figure 12. To compensate for the loss of material during the friction stir weld process, the extrusions were thickened directly adjacent to the planned weld location. At welds where not all of the extra material was used during the weld process, the width of the weld remained raised compared to the surrounding aluminum deck panel, preventing complete contact between the aluminum panel and steel stringer.

is preferred so that the finished product matches the conditions assumed for design. The varying gaps between the generation I panel and stringers is due to the weld fabrication process. The generation II panel has a small gap between the panel and stringer due to the buildup of material required for the weld connection. Welds are typically ground after friction stir welding to remove residual burs and fins. For the generation II panels, it may be possible to grind the welds flush on the bottom of the panel where the panel will be in contact with the supporting steel beams. Although the gap is much smaller for the generation II panel than for the generation I panel and may not be fully correctable due to required fabrication tolerances, it should be minimized as much as possible.

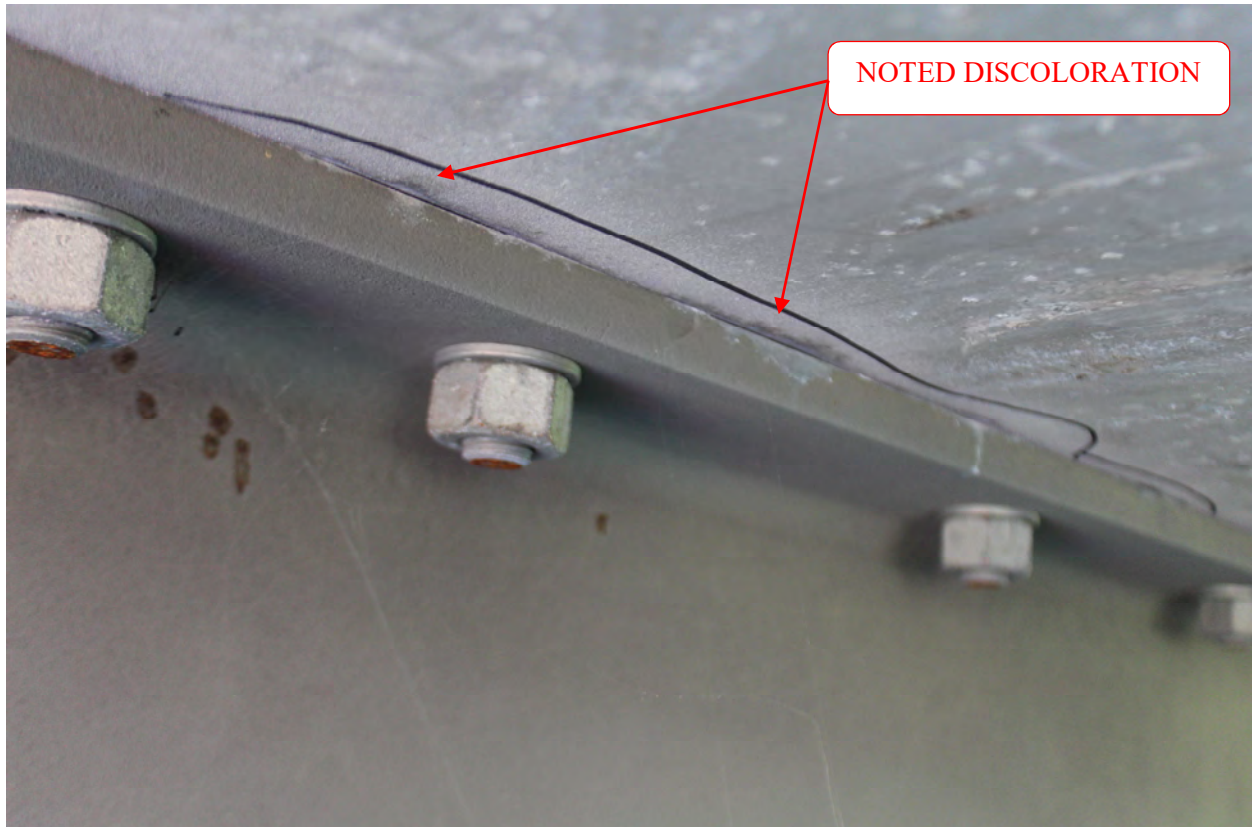
Figure 13: Black Discoloration Noted during Final Inspection

The design for the aluminum panel and steel stringer bolted connection is a faying surface with slip critical bolts. The design assumes the connection slips during thermal movements but not during typical traffic loading. If slippage occurs frequently enough, the inorganic zinc coating on the steel stringers may wear off and cause galvanic corrosion between the aluminum panel and steel stringers. The faying surface was inspected after all structural testing was completed. There was no evidence of corrosion at the faying surface at that time. However, after HVS testing, several areas of black discolorations were noted. An

example is shown in Figure 13 and evaluation of the noted problem is discussed in the Corrosion Testing section.

The black discoloration previously noted in the visual inspection section was inspected due to corrosion concerns. The discoloration appearing in the abrasive blasted faying surface of the deck does not seem to be of serious concern. Examined at 60x magnification, Figure 61, the metal has not been attacked.
