ALUMINUM LIGHTWEIGHT ORTHOTROPIC DECK EVALUATION PROJECT

FLORIDA DEPARTMENT OF TRANSPORTATION
M. H. ANSLEY STRUCTURES RESEARCH CENTER
WRITTEN BY: CHRISTINA FREEMAN, P.E.
REVIEWED BY: WILLIAM POTTER, P.E.
2017

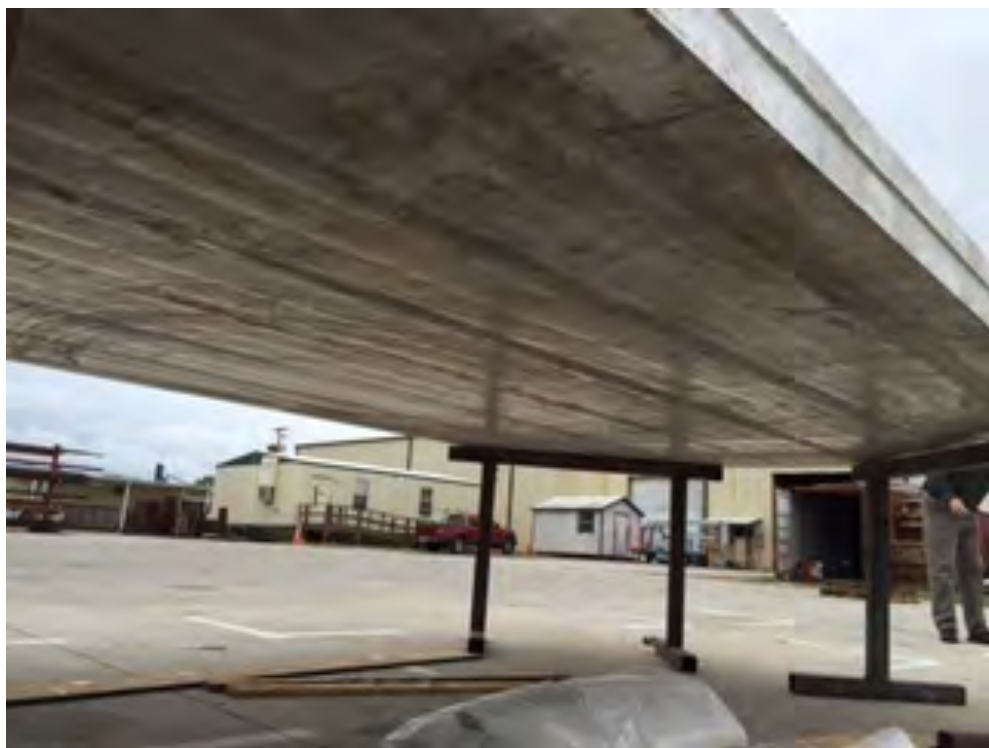
Figure 8: Fabrication Support Conditions

Additional evidence of galvanic corrosion documented during the preliminary photographic inventory consisted of a diagonal affected area approximately 2 inches wide and eighteen inches long, located between stringers 2 and 3 on the generation I panel. Galvanic corrosion is evident by rust colored staining and minor pitting, shown in Figure 7. Figure 8 shows the aluminum panel was supported by bare steel during storage. The location of the supports coincides with the documented galvanic corrosion, therefore the corrosion is likely due to contact with dissimilar metals during fabrication. For future use, Specifications should be incorporated to ensure proper handling during fabrication and installation. The manufacturer and contractor should have proper quality controls in place to verify the aluminum does not come in contact with dissimilar metals during the fabrication process. If proper controls are not in place, service life of the product could be reduced.

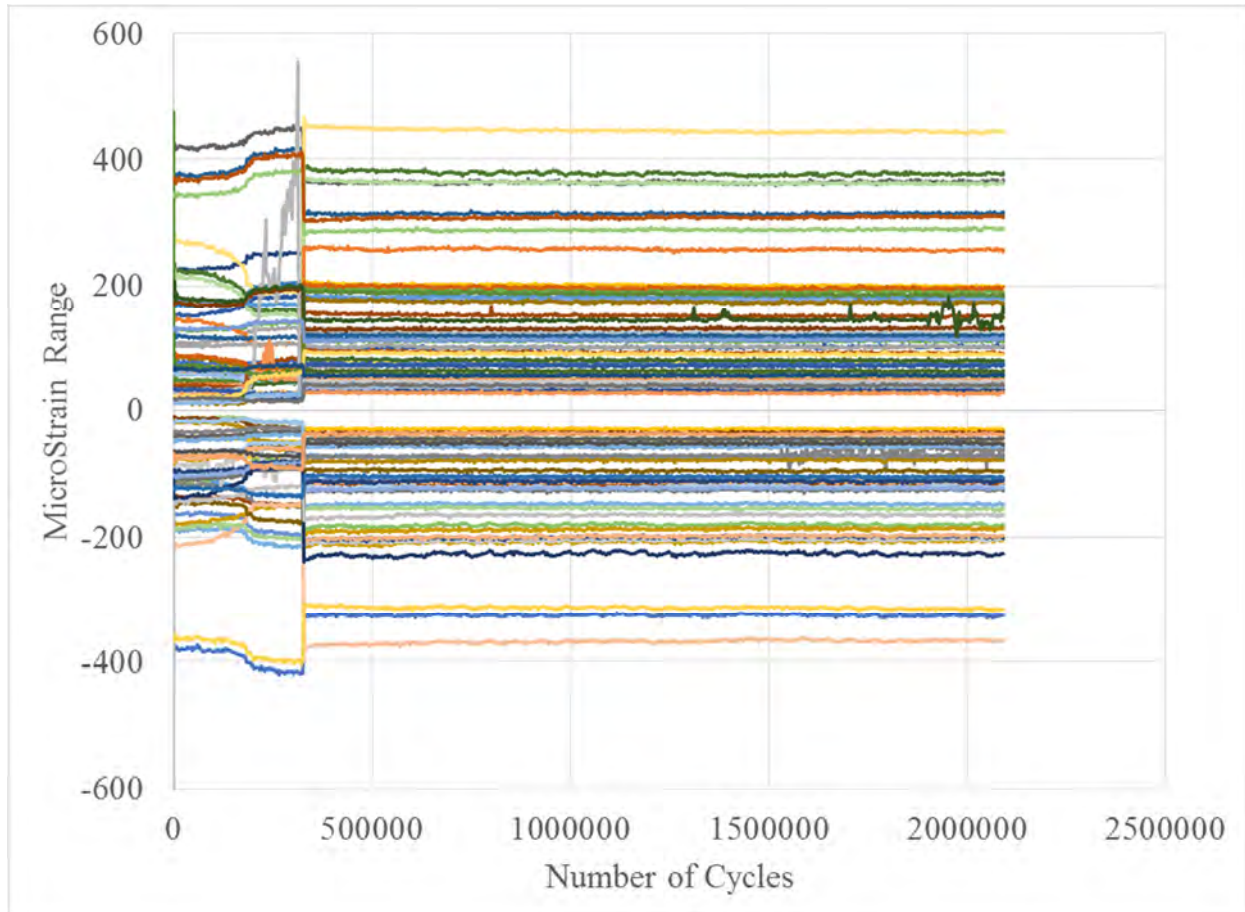
Figure 27: Strain Range versus Number of Cycles

At approximately cycle 330,000, the support bearing pad closest to gage location F1 failed. The test was stopped and the bearing pad replaced. The bearing pad had increased deflection prior to failure, therefore the results presented in Figure 27 show high variability before the bearing pad replacement. However, after the bearing pad was replaced, the results show good, consistent strain readings for the remainder of the test.

Prior to replacement of the failed bearing pad, the stresses generally increased in the positive bending region and decreased in the negative bending region. The behavior is logical as the deterioration of the bearing pad essentially reduced the support of the center stringer. As a result of the failed bearing pad, the panel resisted a higher fatigue demand than planned.

The strain growth rate was estimated based on a linear regression analysis of the strain range between the bearing pad replacement and the end of the test. The largest strain growth rate in the data set was approximately 10 microstrain. Since the strain growth is insignificant, minimal to no structural degradation occurred during the cyclic test.

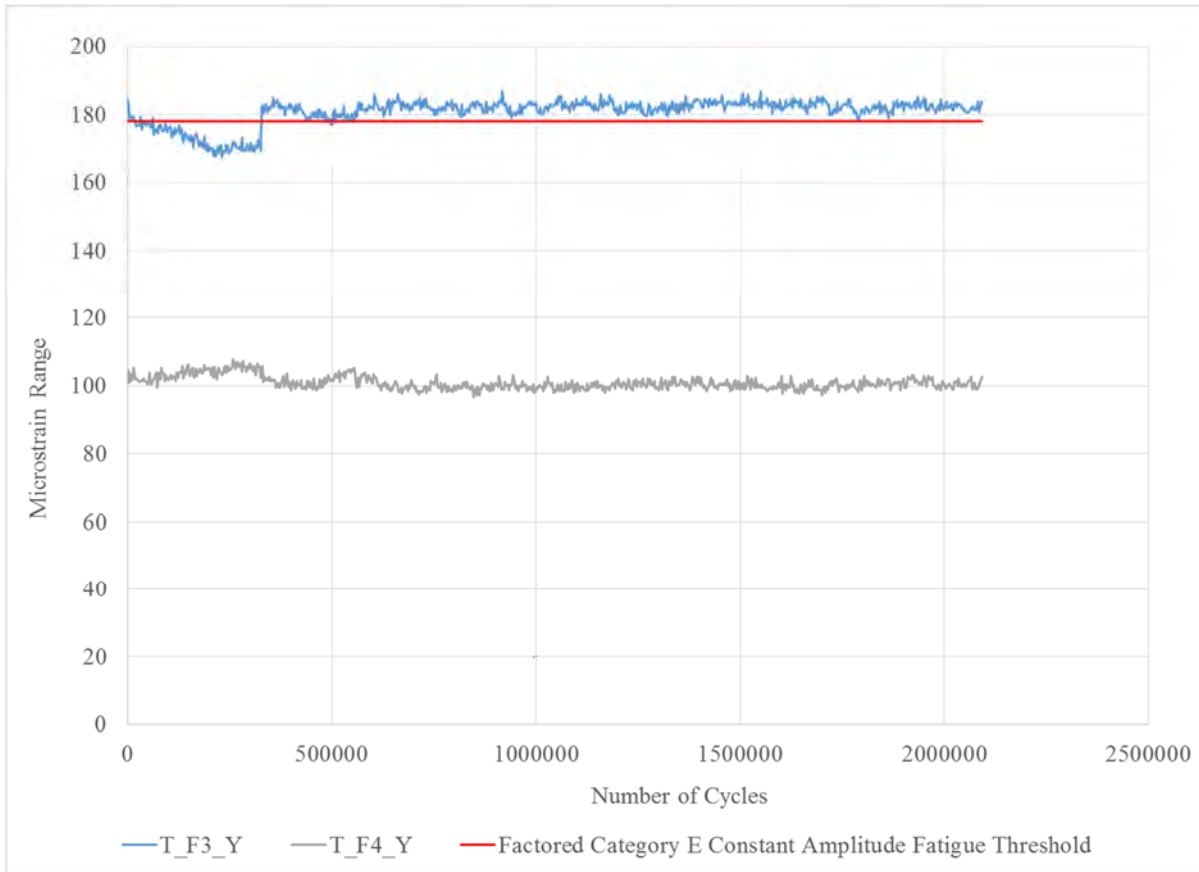
Figure 34: Tensile Strain Range Transverse to Weld vs. Number of Cycles

The friction stir weld joining the aluminum panel extrusions is classified as a Category E detail per AASHTO LRFD Table 7.6.2.3-1. [7] Category E details have a constant amplitude fatigue threshold of 1.8 ksi per AASHTO LRFD Table 7.6.2.5-1, equivalent to 178 microstrain for the aluminum material tested. A higher constant amplitude fatigue threshold for friction stir welds may be appropriate based on limited research, but available design codes do not yet provide guidance for the types of single-sided friction stir welds with permanent backing used for the test specimen. [8] Figure 34 shows the strain range measured in the direction transverse to the weld over the duration of two million loading cycles. The strain range shown is the difference between the maximum and minimum strain recorded in each ten second data set.

Figure 34 provides a comparison between the constant amplitude fatigue threshold and maximum recorded strain range, for fatigue evaluation purposes. Gage T_F4 is positioned directly at the weld seam on the top plate of the panel. Gage T_F3 is located 2 inches from the weld seam on the top of the panel. None of the other longitudinal gages on the top of the panel were located close to a weld. All other longitudinal gages on the top of the panel and all longitudinal gages on the bottom of the panel have tensile strain ranges below 120 microstrain. Gage T_F3_Y has the highest recorded longitudinal tensile strain range. The measured value is close and slightly higher than the constant amplitude fatigue threshold. The average strain range measured at gage T_F3_Y is within 1% of the constant amplitude fatigue threshold and therefore the weld detail for this test specimen can be considered to be within the infinite fatigue life stress limit. However, this particular test specimen has been subjected to a significant number of loading cycles during the testing regimen representing approximately half of its fatigue life and non-ferrous metals such as aluminum do not have distinct endurance limits like ferrous materials such as steel. Therefore, the remaining fatigue life for this test specimen should be evaluated and it should be inspected on a regular basis if placed in service for a trial period.

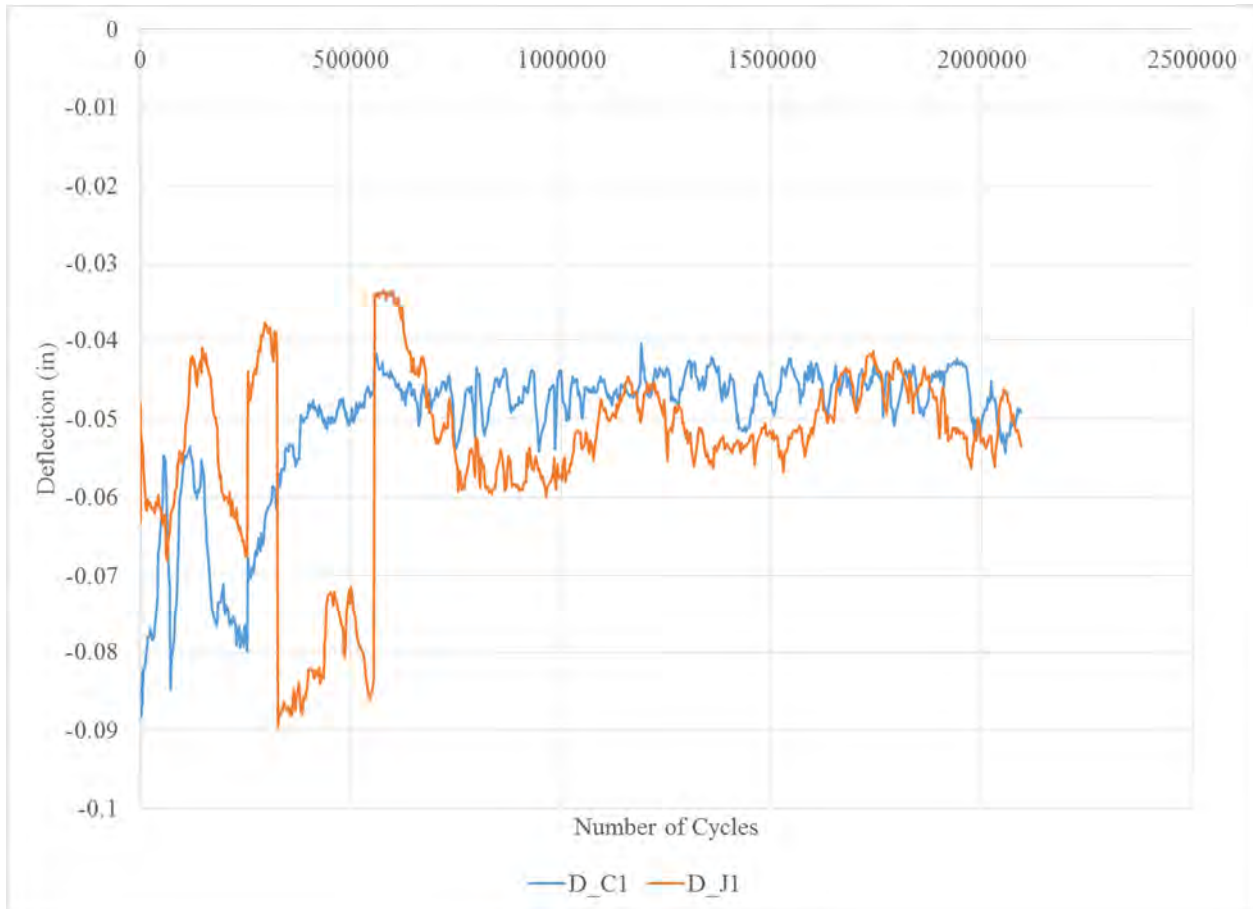
Figure 35: Deflection vs. Number of Cycles

The maximum deflection occurs directly under each loading point, at mark C1 and J1. The deflection readings at those locations were corrected by the support deflection readings to remove the deflection due to the bearing pad supports. The deflection at mark C1 was corrected by the average of the deflections at gages GD1 and D_F1. The deflection at mark J1 was corrected by the average of the deflections at gages D_F1 and GD3. Refer to the Instrumentation Plan in Appendix A: Structural Testing Procedure for those gage locations. The corrected data is presented in Figure 35. The increased deflection from zero to cycle 330,000 is due to failure of a support bearing pad. Gage D_J1 also appears to have malfunctioned between cycles 330,000 and 550,000. Although noisy, the deflection readings are stable over the cyclic loading test, after cycle 550,000.

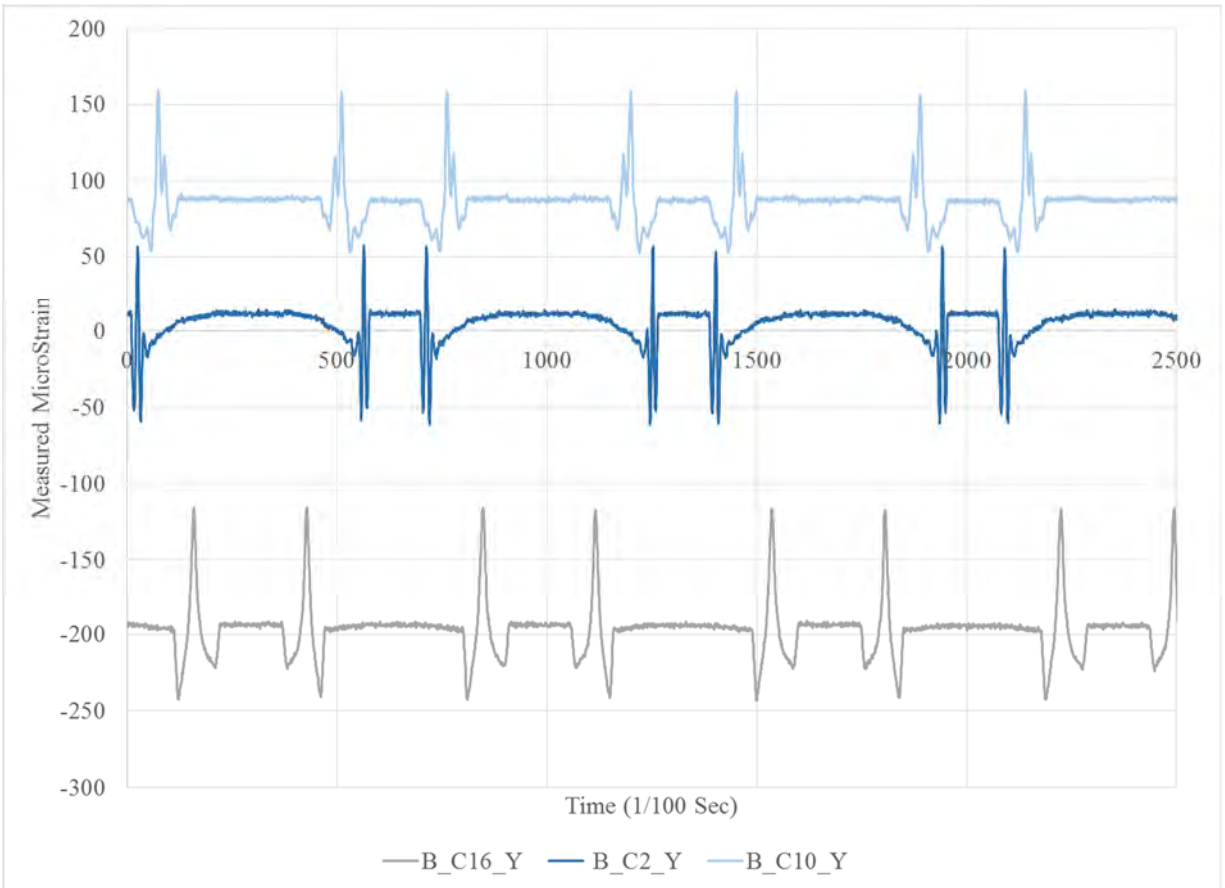
Figure 49: Recorded MicroStrain on 5/26/2016 at 1 AM for Gages B_C16_Y and B_C2_Y

Due to the moving nature of the Heavy Vehicle Simulator load, stress reversal occurs for strain in the travel direction of the tire load. The maximum level of strain reversal was observed at gage B_C16_Y, in the generation I panel. The measured strain showing the stress reversal behavior is shown in Figure 49. Gage B_C16_Y had the highest recorded strain range for gages in the travel direction of the tire. Measurement at gage B_C2_Y is also included in Figure 49 as that gage had the highest recorded strain range for the generation II panel. Gage B_C10_Y is included as that gage is at a similar position in the generation II panel as gage B_C16_Y for the generation I panel.

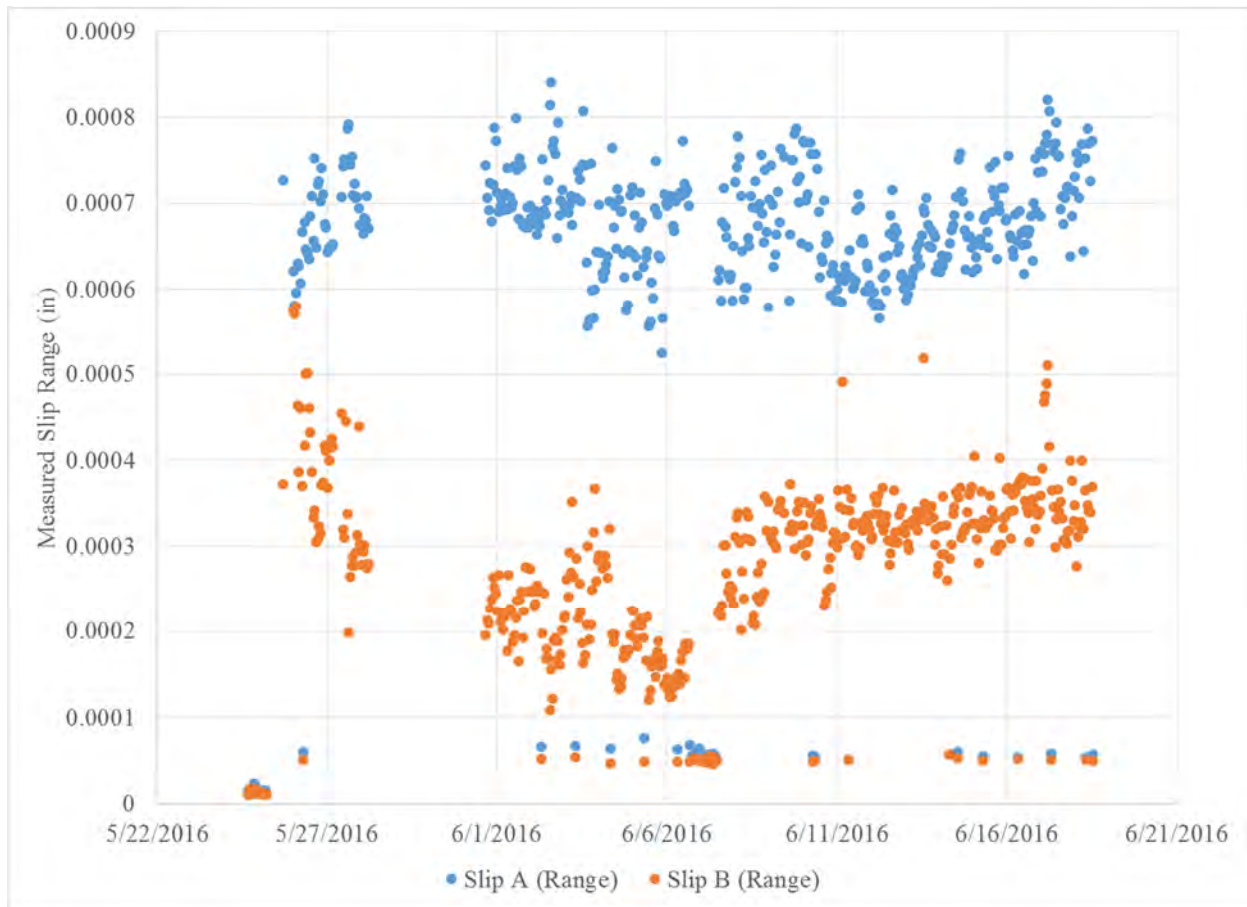
Figure 53: Slip Range Measurement vs. Time for Entire HVS Test

Evident from Figure 53 is that slip readings for gage A, on the generation I panel are consistently higher than readings for gage B on the generation II panel. The average reading for gage A is approximately double the average reading for gage B. The gap between the panel and stringer is larger for the generation I panel than the generation II panel and may be the cause of higher slip readings.

The recorded slip is clearly a function of structural loadings since readings start and stop according to when the heavy vehicle simulator was running. The cause is unknown. The recorded measurement is potentially due to axial compression, bending in the test specimen, or a combination thereof. Slip readings are much lower than would be expected due to thermal loads, by a factor of 100. The panel may not be performing as designed since slip due to thermal loads was not observed during testing. Inherent conservatism in the design of the faying surface and slip-critical bolted connection is a likely reason that the panel does not slip due to thermal effects. The behavior does not appear to be detrimental to performance of the system and the lack of significant slip between the panel and stringer may be preferred so that the inorganic zinc coating does not wear off of the steel beam and result in corrosion between the dissimilar metals.

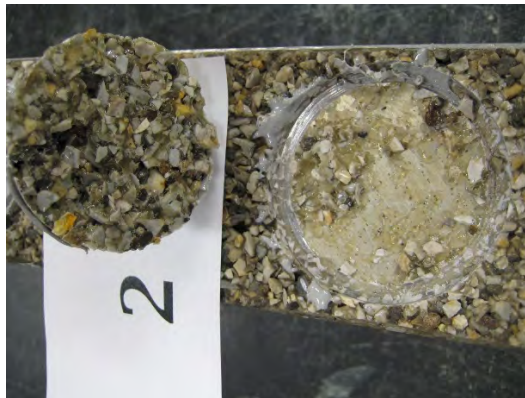
Figure 55: Bond Test 1C, Location 2

The results of the laboratory tests are presented in Table 5. Odd numbered locations were tested under laboratory temperature after allowing the epoxy adhesive to cure for about 1.5 hours, while even numbered locations were tested after an additional 2 hours of placement in a heated chamber. The bond strength at Location 9a exceeded the capacity of the tester at lab temperature. Location 9 was retested at elevated temperature since the dolly was still affixed and the results are presented as location 9b. The temperature of each location was measured with an IR thermometer immediately after each test. Figure 55 and Figure

Location	Bond Strength (psi)	Failure Mode	Temperature (°F)
1	396	~75% epoxy/dolly, ~25% intra-epoxy	75.5
2	288	~85% overlay/Al, ~15% intra-overlay	114.5
3	232	~75% epoxy/dolly, ~25% intra-epoxy	75.5
4	294	~30% overlay/Al, ~50% overlay fail, ~20% epoxy/dolly	115.5
5	220	~100% epoxy/dolly w/neg. epoxy failure	75.5
6	256	~20% epoxy/dolly, ~80% intra-overlay	114.5
7	542	~90% intra-epoxy w/Agg pull out, ~10% epoxy/dolly	75.0
8	405	~30% epoxy/overlay w/agg pullout, ~70% intra-epoxy	110.5
9a	548	Reached the maximum capacity of tester without breaking	75.5
9b	324	~20% overlay/Al, ~80% intra-overlay	110.5
10	373	~30% intra-epoxy, ~70% intra-overlay	108.5

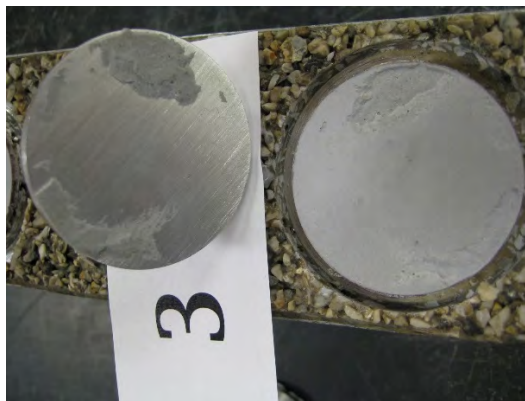
Figure 56: Bond Test 1C, Location 3

Considering only the results of bond tests 1B and 1C, since the results of test 1A were inconclusive, there were two test locations with a bond strength less than the required 250 psi. Those tests were locations 3 and 5 for test 1C. For both of those tests, the failure mode was within the epoxy used to bond the steel dolly to the overlay or at the bond surface between that epoxy and the steel dolly. Per ASTM C1583, section 11.4, results should be discarded if that failure mode occurs. Therefore, the bond test indicates the wearing surface applied to the lightweight aluminum full size test specimen and smaller sample has an acceptable bond strength of greater than 250 psi.

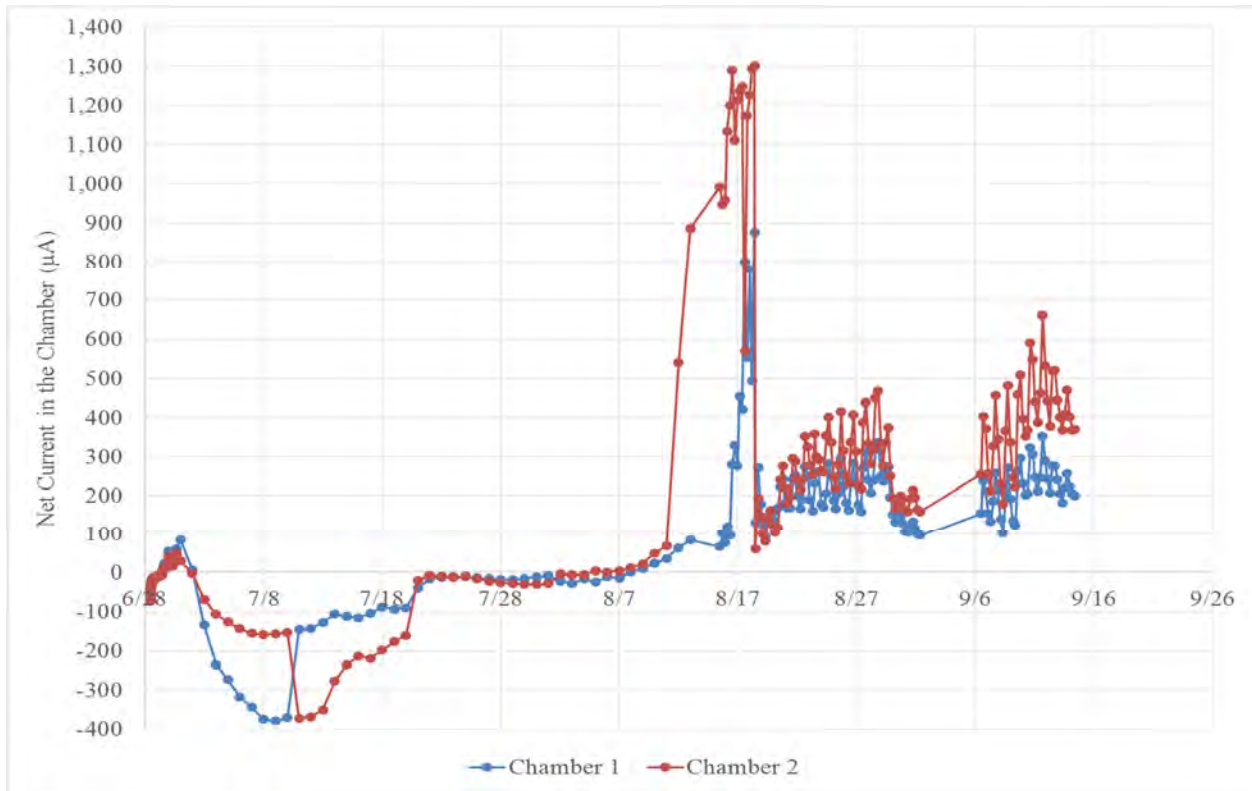
Figure 59: Net Current between Hollo-Bolts and Aluminum Deck

The corrosion test specimens show a dark discoloration of the aluminum surface. The testing indicates the aluminum is slightly anodic with respect to the fasteners (positive current) as an examination of the galvanic series in seawater would concur. That is, the aluminum is presently providing a small measure of cathodic protection to the galvanized fasteners. The oxidation on the fasteners shows there is still some consumption of the zinc. As the zinc is consumed, the corrosion current will likely increase since iron and aluminum are farther apart on the galvanic series. The net current measured to date is shown in Figure 59. It is unlikely the corrosion will be as severe in actual service given the exposure will probably be limited to light salt spray or mist rather than full, long-term immersion.

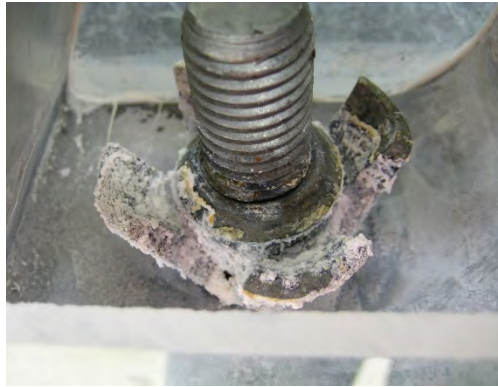
Figure 60: Fastener Used for Corrosion Testing

Further testing qualitatively evaluated corrosion of plastically deformed fasteners. Two Hollo-Bolt fasteners were used to attach steel plate coupons to a section of a Generation I deck specimen, as shown in Figure 60. The bolts were torqued to manufacturer's specification. The intent of the test was to qualitatively gauge how severe the corrosion might get as well as look into possible crevice and stress related corrosion effects.

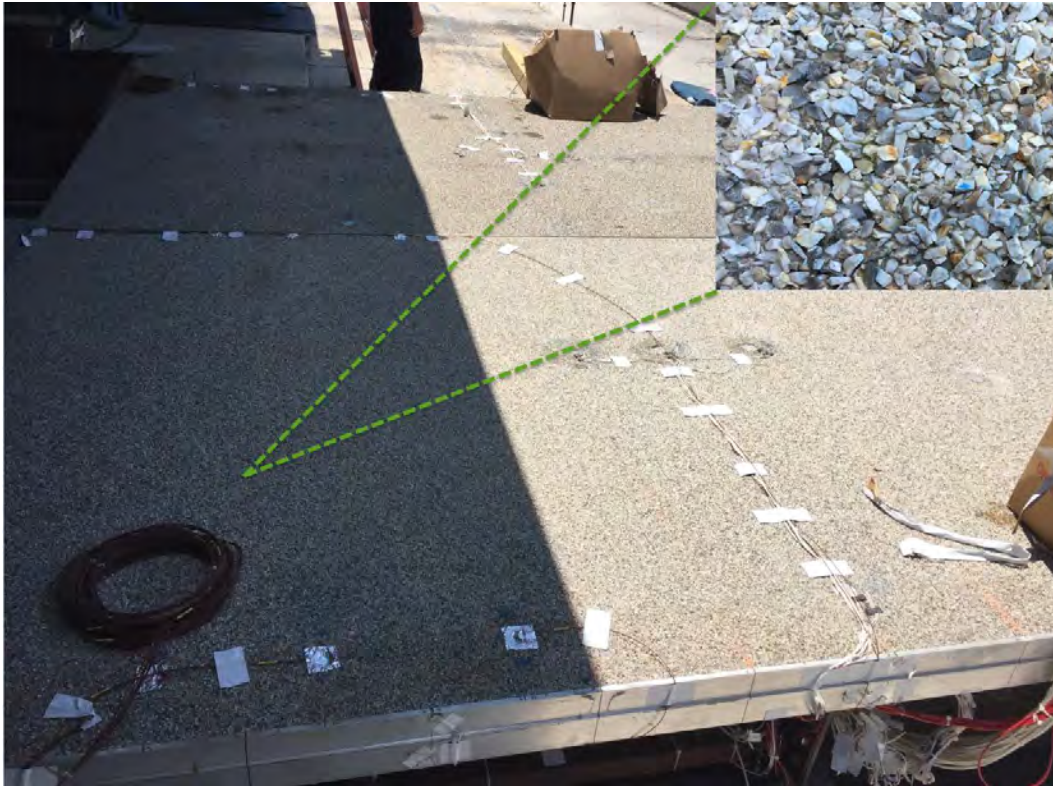
Figure 1. Aluminum bridge deck with a close up view of the aggregate.

A special request was made to evaluate the friction and texture characteristics on an aluminum bridge deck overlaid with a skid-resistant wearing surface under three loading phases: (1) preload, (2) 1st 300,000 Heavy Vehicle Simulator (HVS) passes on dried surface condition at an elevated temperature of 120°F and (3) 2nd 300,000 HVS passes on wet surface condition. The skid-resistant wearing surface is a ¼" overlay, which consists of the Flexolith two-part epoxy resin mixed with basalt aggregate. Figure 1 shows the picture of the aluminum bridge deck with a close up view of the aggregate.

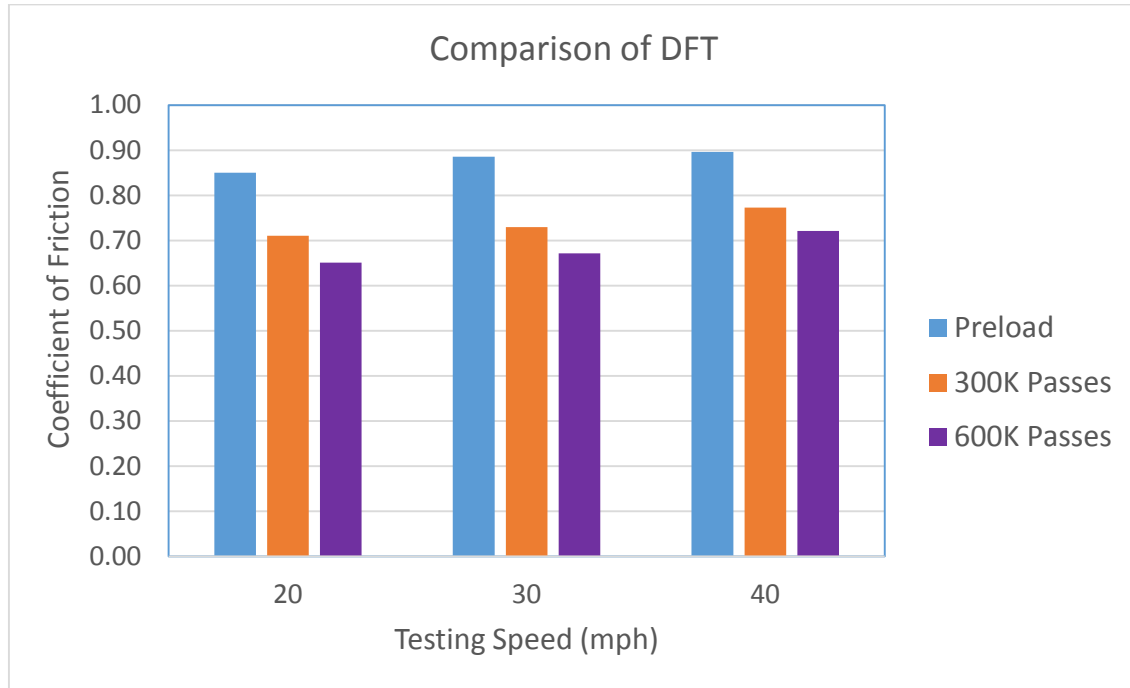
Figure 3. Comparison of average DFT measurements between Preload and 300K HVS Passes

The equivalent FN40Rs for three loading phases exceed the requirement of 55 according to the developmental specification 403-Epoxy Overlay for Sealing and High Surface Treatment on Concrete Bridge Decks. Figure 3 shows the comparison between preload phase and the 1st 300K HVS passes. As shown, the coefficient of friction dropped about 20% on averaged after 600K HVS passes.

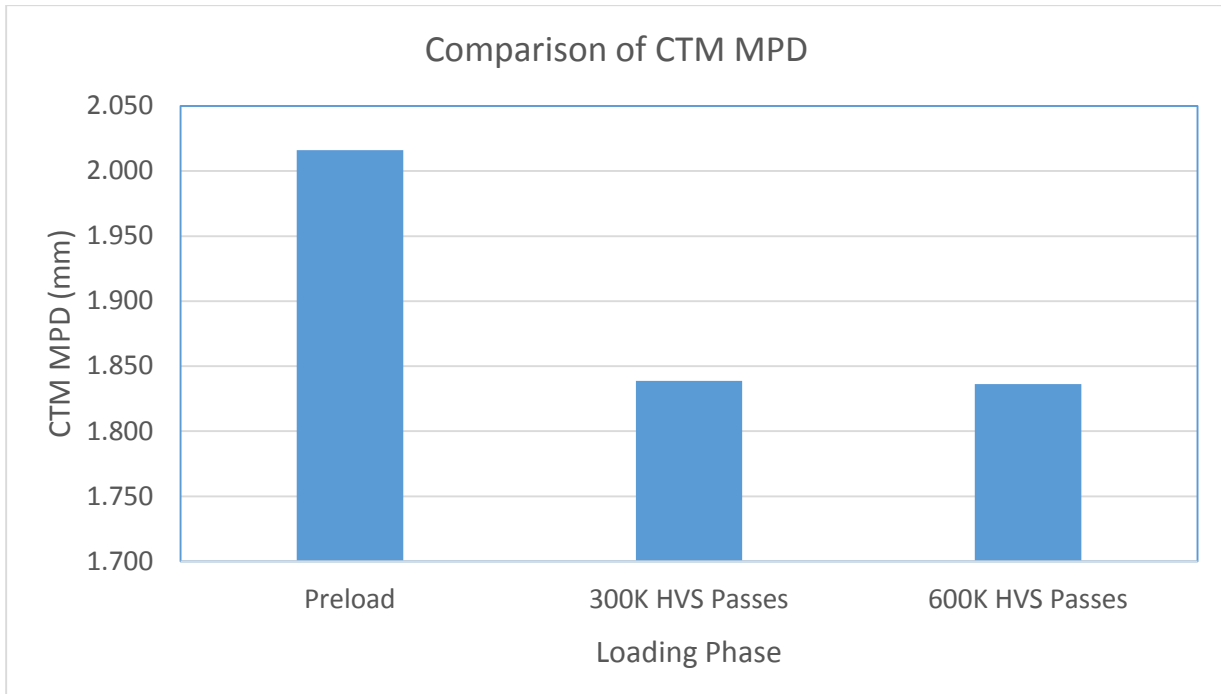
Figure 4. Comparison of average CTM measurements among three loading phases

The results of CTM measurements for three loading phases are presented in table 2. Detailed measurements are provided in Appendix I. As shown, the average MPD values are 2.016 mm for preload phase, 1.839 mm after 300K HVS passes and 1.836 mm after 600K HVS passes. For comparison purposes, the average MPD for the aluminum bridge deck section is higher when compared to a typical MPD for newer in-service longitudinal diamond grinding (LGD) concrete pavement (typically 0.6 mm) and longitudinal grind and transverse grooved bridge deck (typically 1.3 mm). Figure 4 shows the comparison among three loading phases. As shown, the MPD has dropped about 9% on average after 300K HVS passes. However, the MPD doesn't change much after 600K HVS passes as compared to the MPD after 300K HVS passes. Figure 5 shows the comparison of the surface texture between preload phase and after 600K HVS passes. As shown the texture seems to show minor aggregate wear and loss after 600K HVS passes. As a side note, due to the high friction surface texture of the deck surface, noticeable tire wear was observed as shown in Figure 6.

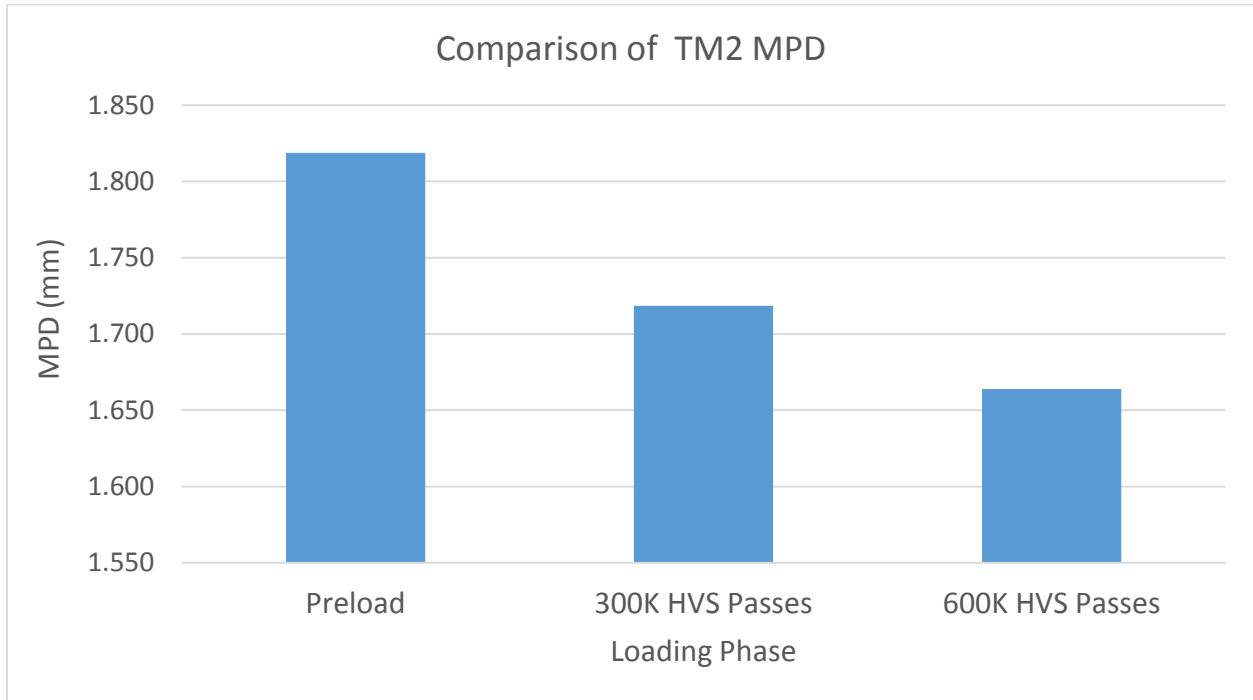
Figure 8. Comparison of average TM2 measurements among three loading phases

The results of TM2 measurements for three loading phases are presented in table 3. A detail dataset is provided in Appendix II. As shown, the average MPD values are 1.819 mm for preload phase, 1.719 mm after 300K HVS passes and 1.664 mm after 600K HVS passes. Figure 8 shows the comparison among three loading phases. As shown, the MPD is dropped about 9% on averaged after 600K HVS passes, which is similar to CTM test.
